Canadian Naval Technical History Association

HMCS *Provider* Vibration Problem

By Cmdre W.J. Broughton, RCN (Ret.)

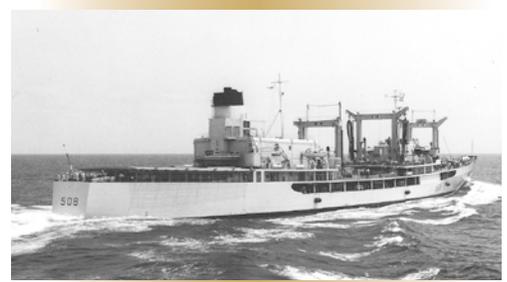
The investigation then moved to an examination of the four-bladed propeller and the ship's wake into it. That's where I became involved. Model tests showed that the wake was very non-uniform and turbulent due to the underwater shape of the after part of the hull. Rather than narrowing gradually toward the stern to allow smooth water flow, the hull transitioned abruptly from a full profile to its final narrow profile in a very short distance. Clearly, as each blade rotated in its circular travel, there was a large variation in the produced thrust because of the great variation in the wake speed entering the propeller's path at the different positions of the blade's rotation. Each blade was seeing a change in wake from a positive to a negative speed of wake entry! As memory serves, the top shaft revolution was about 110 rpm. That would mean a pulsing action from the propeller at a frequency of about 440 cpm from the four blades. It turned out that the propeller pulse frequency was in exact tune with the frequency of the first horizontal mode of the ship's hull as determined by the shaker trial.

Grundy and I discussed possible remedies (not solutions) with senior engineering staff, with the obvious fix being to change the number of blades on the propeller to de-tune the synchronous effect with the hull. After some preliminary analysis I recommended a seven-bladed propeller. More blades, however, would mean a reduction in the propeller rpm and thus an increased torque on the shafting for the same power output. Our gearing and shafting expert, Don Nicholson, confirmed this would not be a problem. The LIPS propeller works in Drunen, Netherlands reviewed our work and agreed that the best remedy would be to increase the number of blades, but recommended a six-bladed propeller. This was subsequently ordered and installed. The fix was successful in eliminating the severe hull vibrations.
