Maritime Engineering Journal

**HMCS *Kootenay*
Repairing the Damage**

HMCS *Kootenay* Collision Repair

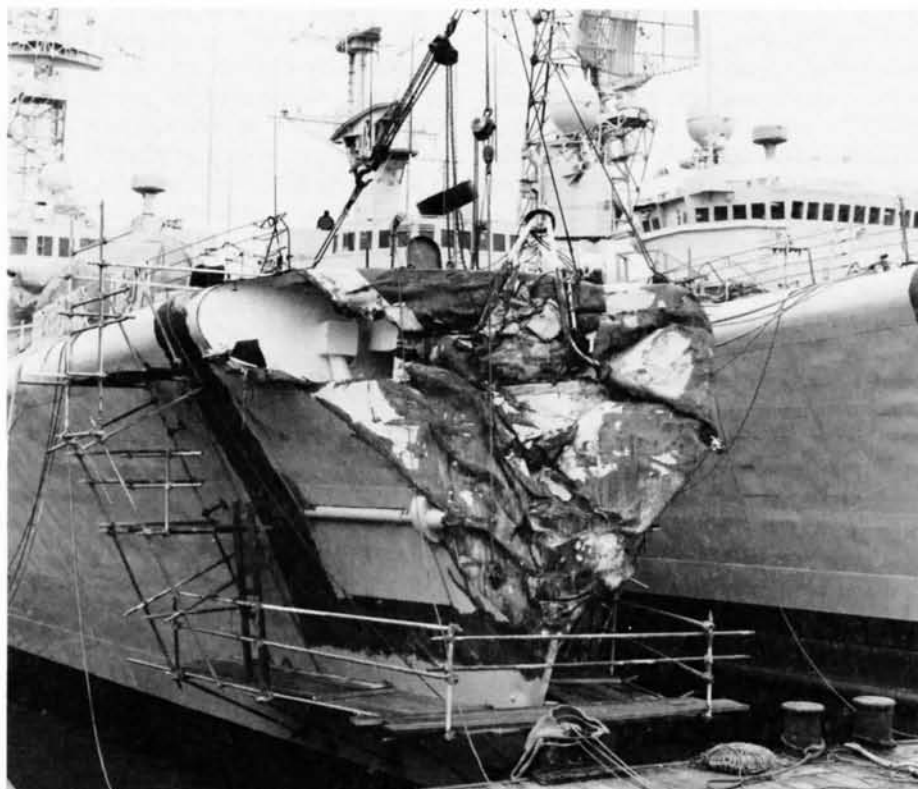
Upon arrival at Esquimalt, *Kootenay* was immediately surveyed by a team of inspectors from the Naval Engineering Unit Pacific (NEUP). It was determined that the damage was limited to the structure forward of the ship's collision bulkhead (Frame No. 2). The bow had been crushed back (Fig. 2) starting from the upper starboard corner of the bulkhead, across the upper deck at approximately 30° and down at a 65° angle to a point on the stem 12 in. above No. 3 deck. The clear geometry of the damage was due to the angle and flare of *Nordpol's* bow and the relative positions of the vessels at the point of impact (Fig. 3).

Fig. 2. *Kootenay's* crushed bow section is prepared for removal. No damage was sustained abaft the collision bulkhead.

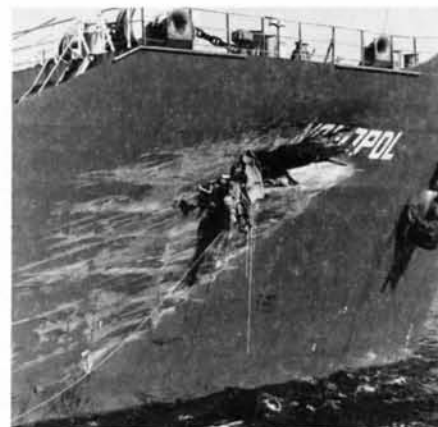
Fig. 1. Bow section of the MV *Nordpol* following the collision. A crumpled piece of *Kootenay's* steel plating protrudes from the gash.

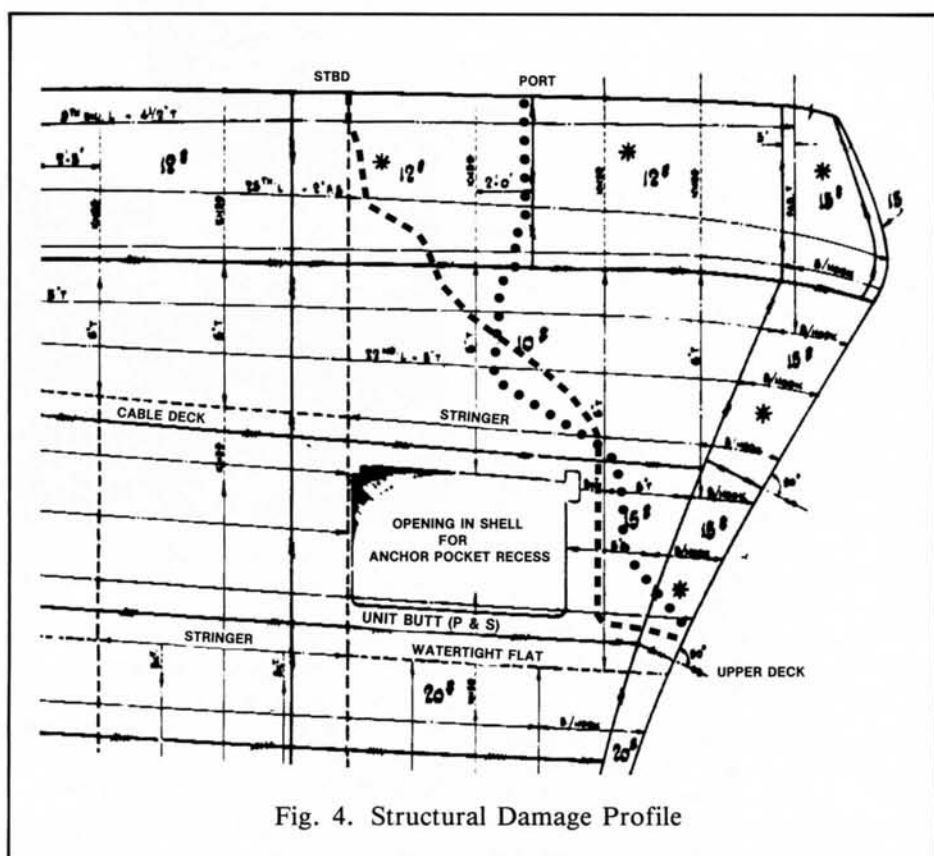
Fig. 4. Structural Damage Profile

Chance provided a second option. A sister ship, *Chaudiere*, was being stripped in Esquimalt prior to disposal. As *Kootenay's* damage (Fig. 4) was limited to one of the ship's original prefabricated units (No. 31), it was considered feasible to exchange bows. The process would be similar to the original construction method and was the preferred option if alignment of the unit proved possible.

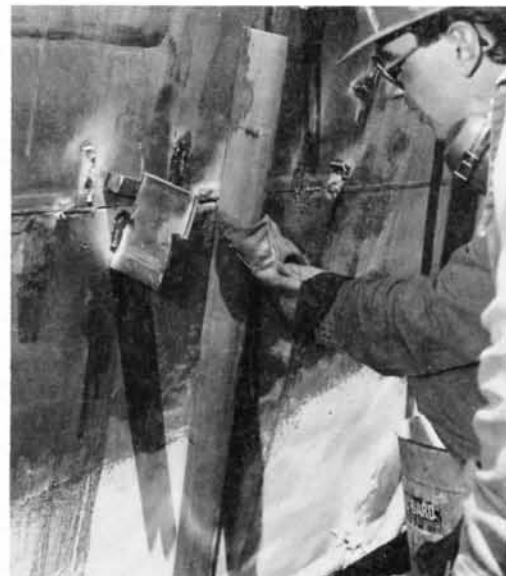
Fig. 7. Fairing the hull using L-brackets.

Fairing the shell plating was achieved by welding an L-shaped bracket to whichever was the lower of the two plates on either *Kootenay* or the bow unit (Fig. 7). A wedge was then driven under the open end to force the proud surface into line. Once in line, the plates were tacked together. The process was started on the upper deck amidships and proceeded outwards. This drove any "wrinkles" out to the sides and down to the bottom of the unit where they would be trimmed off. The deck, round-down sides and lower seam of the unit were all eventually faired to the main

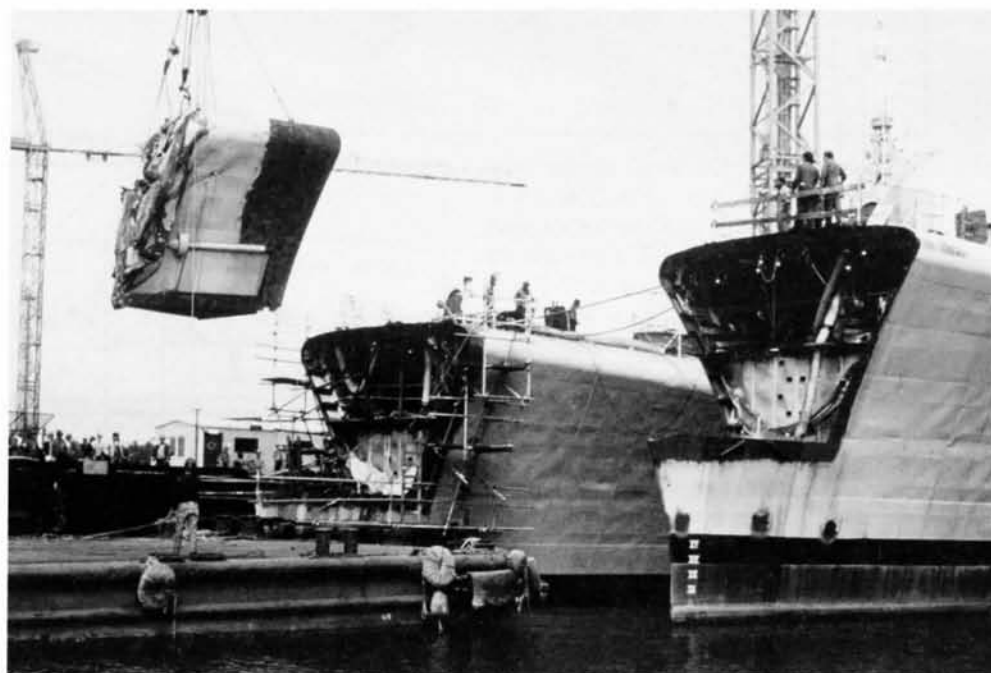
Fig. 5. As the bow section is landed on B Jetty, the 65° line of damage is clearly visible. (Photo by R.L. Hopkins, QHM Esquimalt.)

butt on the deck and side-shell respectively. The frames were cut 3 in. proud of the seam. *Kootenay's* bow was cut along the butt joint of pre-fab unit 31. The longitudinals were cropped back 12 in. and 20 in. from the cut along the deckhead and side-shell respectively. The frames were cropped back to 3 deck. The damaged bow was removed (Fig. 5) on the 13th of June.

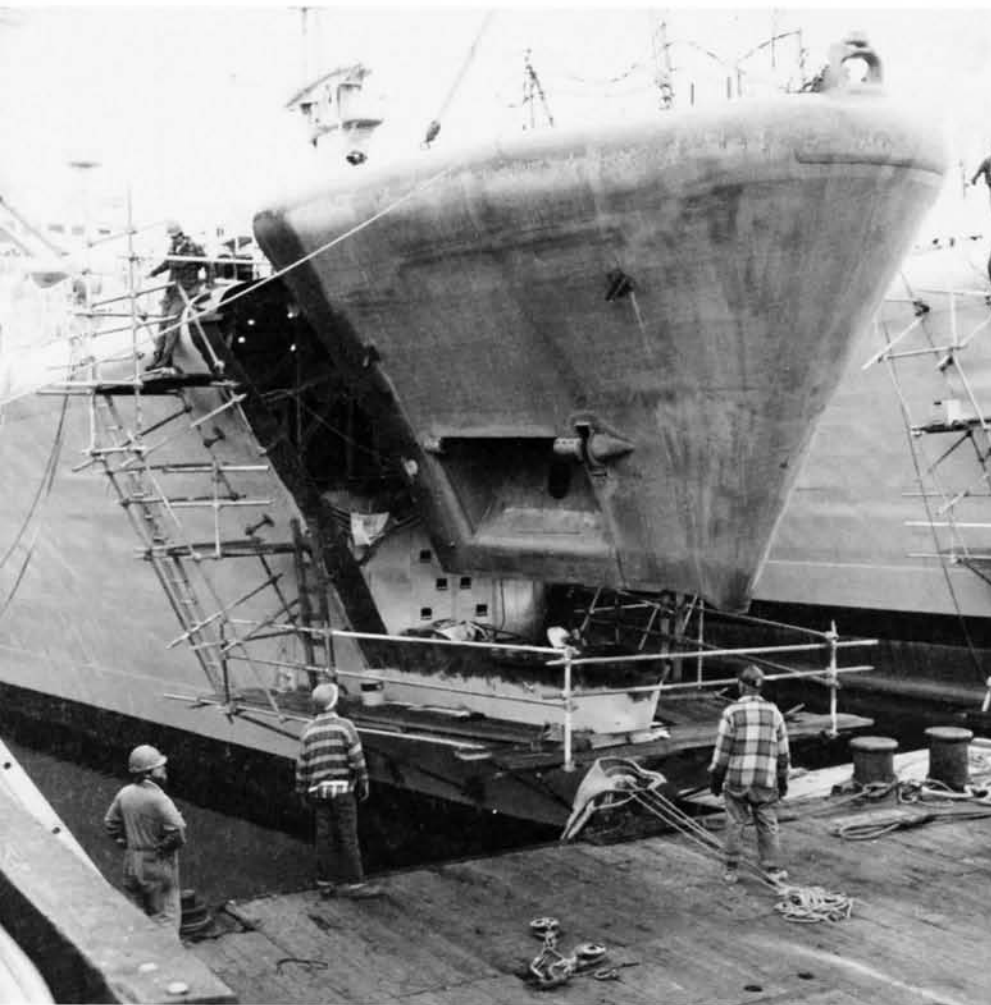
Fig. 6. The "new" bow unit from *Chaudiere* is lowered onto *Kootenay*.

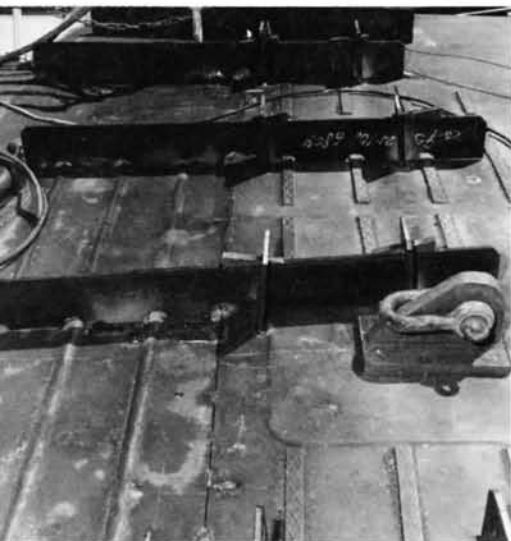
Fig. 8. Preparing for final welding, strongbacks are welded and wedged into slotted brackets on either side of the weld-line to prevent distortion.

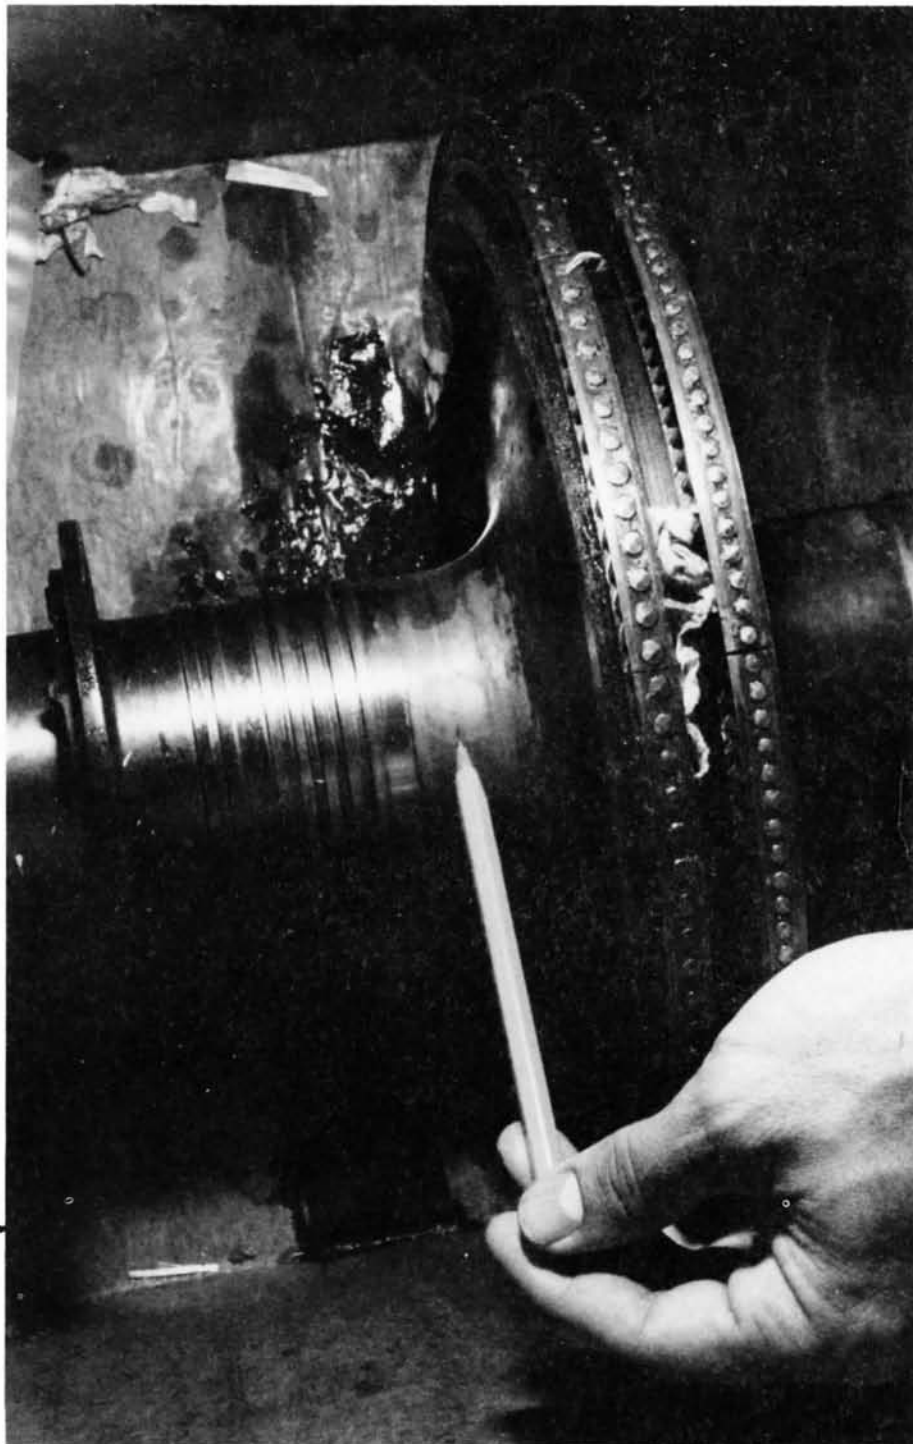
Fig. 4. An acid etching process was used to reveal this hot spot.

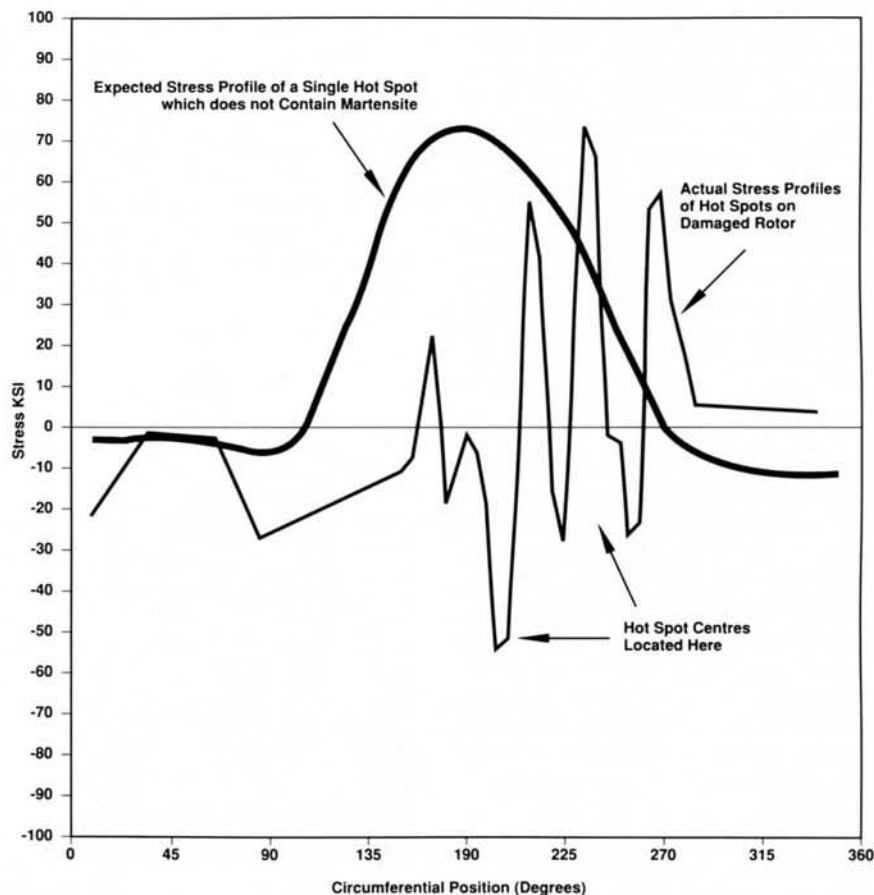
Figure 5 shows both the expected stress profile of a hot spot and profiles of two actual hot spots on the same rotor. The very high levels of compressive stresses at the centre of the hot spots indicated the rotor had been overheated, and the critical phase transformation temperature exceeded.

Fig. 5. Residual stress measurements, showing hot spots on repaired rotor No. 2.

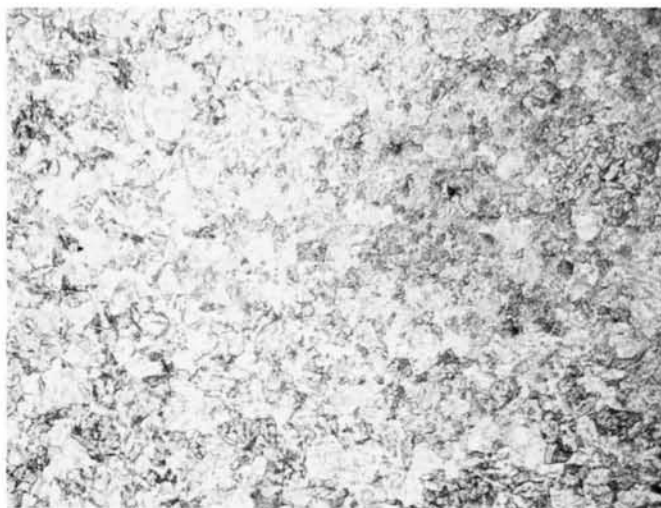
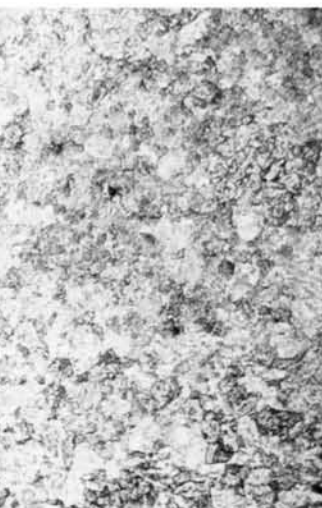
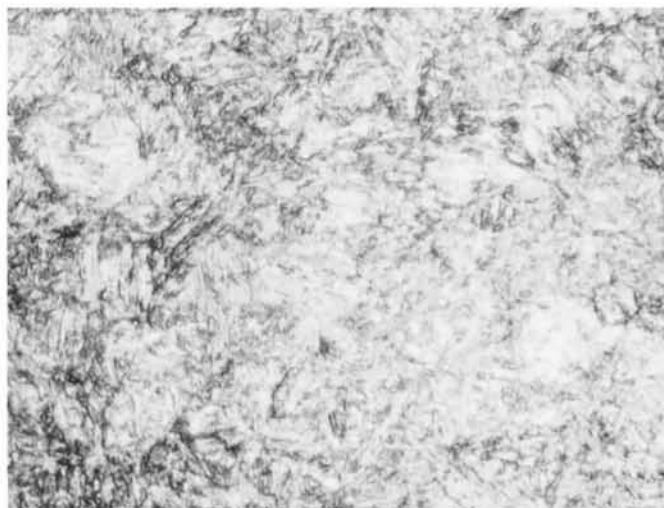
Fig. 6. Hot Spot Microstructure

The presence of martensite could only be confirmed by microscopy. A section was cut through a hot spot (for by this time a damaged rotor was available for destructive analysis), and was polished and etched. Once under the microscope quite vivid inconsistencies were observed in the microstructure (Fig. 6). The areas at the centre of the hot spot were identified as martensite. As well as containing high levels of residual stress,

Residual stresses in rotors which contained martensite would progressively relax in service, allowing the rotors to return to their "original" bent condition. Depending on the turbine speed at which this occurred, a rotor would damage not only the stator, but would cause local overheating in itself along one side. This would increase the degree of rotor distortion, cause the rotor to wipe out the fin packing and gland labyrinths, create wide clearances, cease to rub, then cool, and in some cases, bend in the opposite direction — just like a hot spot process — and rub with the opposite side. Sometimes, once cooled, the rotor would be straightened by this process.
