Maritime Engineering Journal

September 1989

RAST MK III

**A new-generation
helicopter handling
system**

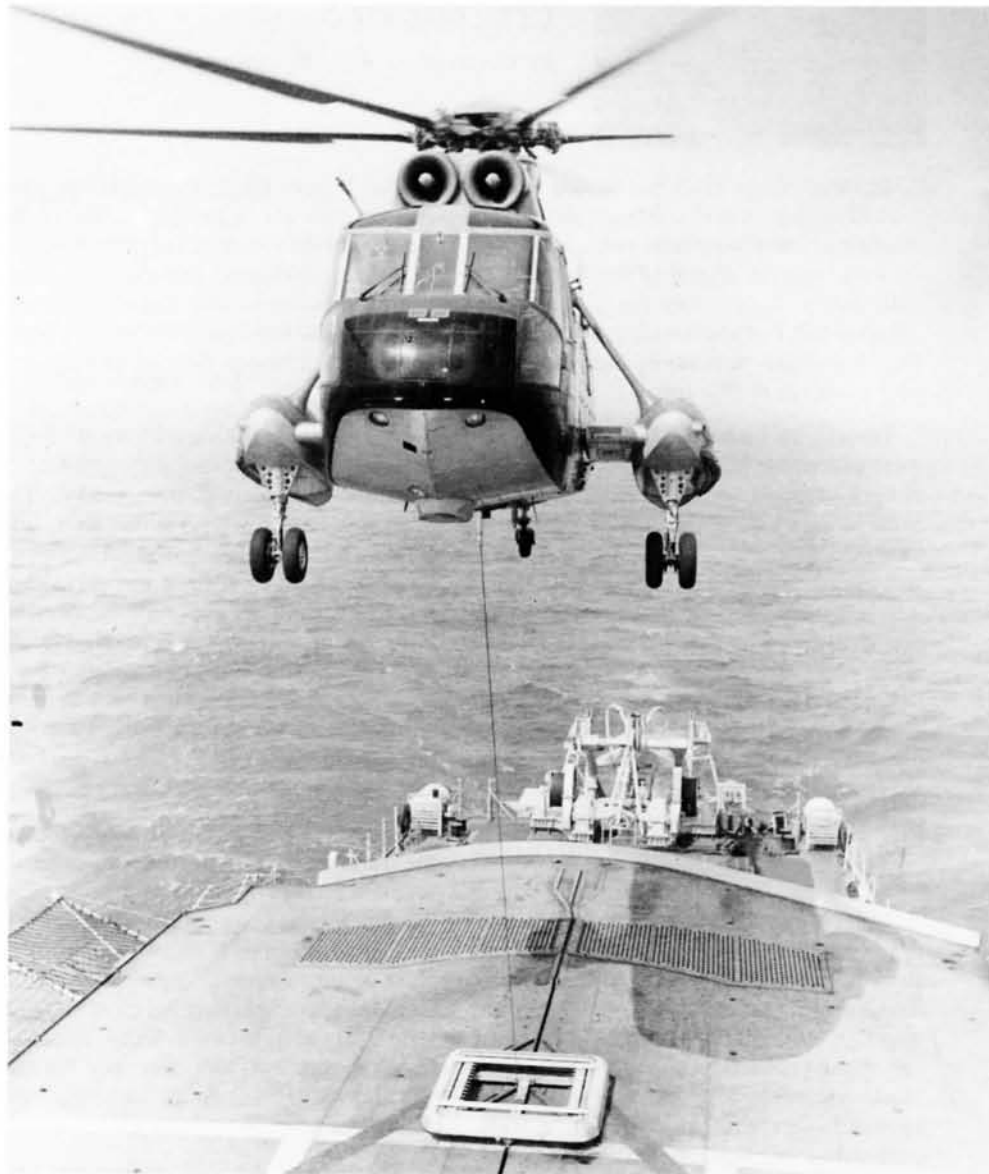
Figure 1. "Flying the wire," necessary with the HHRSD, RAST MK I and CPF RAST systems, will become a thing of the past with the "wireless" RAST MK III. (DND photo)

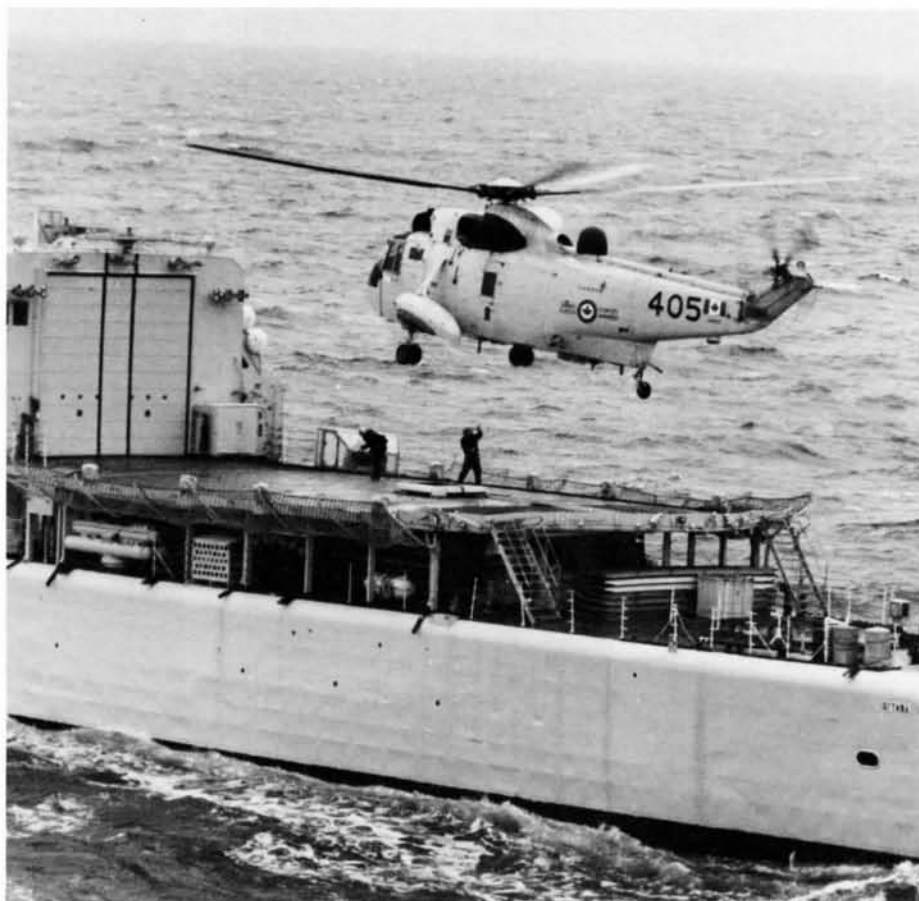
Figure 5. RAST MK III eliminates the requirement for flight-deck personnel during recovery/launching operations. (DND photo)

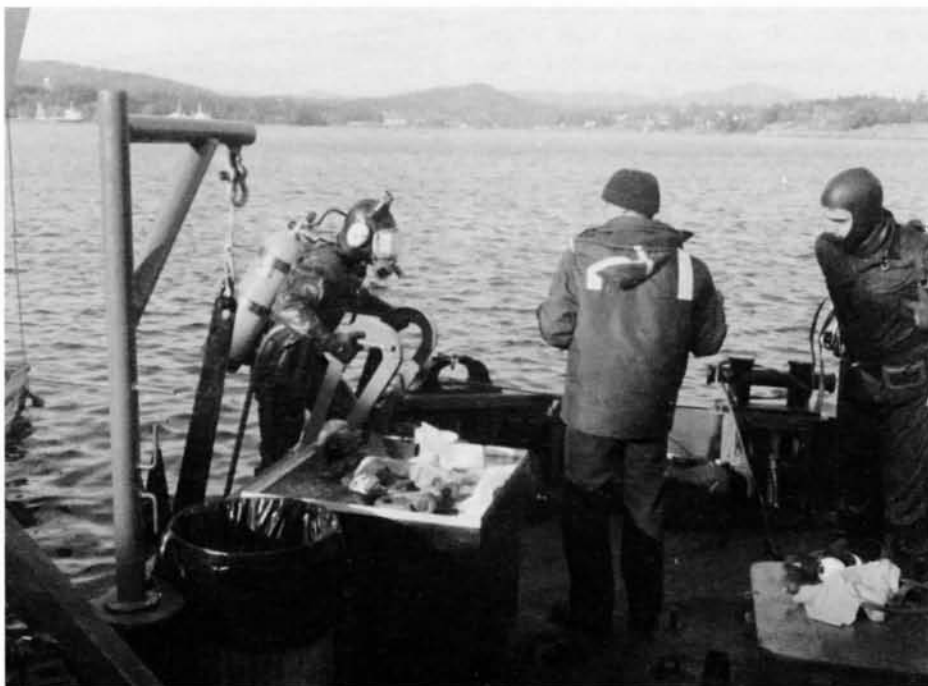
Figure 1. Divers PO1 Frew and LS Brewka change tanks as they prepare to make another dive on *Huron*. Underwater communication sets and hull-mounted video equipment made the blade-replacement job easier for divers and supervisor.

The job started on the first Monday in December, a typically beautiful West Coast day that boosted our confidence. Work began by securing a crane barge alongside *Huron*. An underwater video camera was mounted on the hull of the ship, and the divers were equipped with communication headsets (Figure 1) that later proved to be worth their weight in gold. Problems could be discussed and solved on the spot.

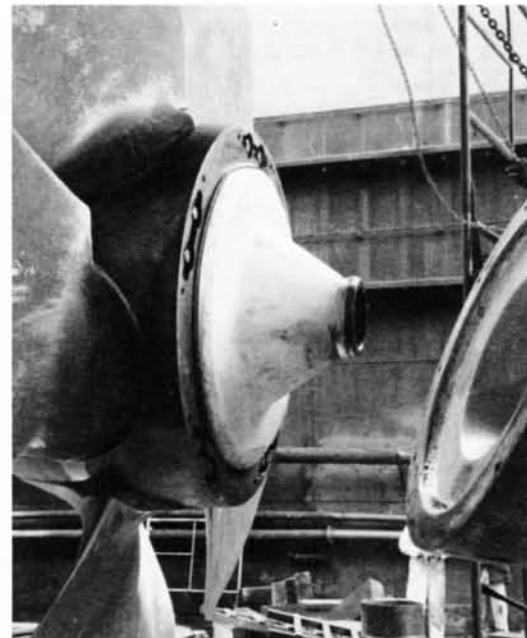
Figure 2. With the foam-filled fairing cone pulled away (right), the white tallow pressed against the hub is revealed. This part of the underwater operation required careful planning to prevent the buoyant cone from floating away out of control.

After rigging the eye-bolts and chain blocks the fairing cone was removed (Figure 2). There was much speculation whether the half-ton cone would float or sink as it was filled with foam and sealed by fiberglass. Since there was more danger to the divers if it floated out of control, it was decided to suspend a weight from the cone. Several bolts securing the cone to the hub were removed and tapered pins inserted in their place. They would act as guides as the cone was pulled back from the hub and would also prevent the cone from floating away if it were improperly weighted.

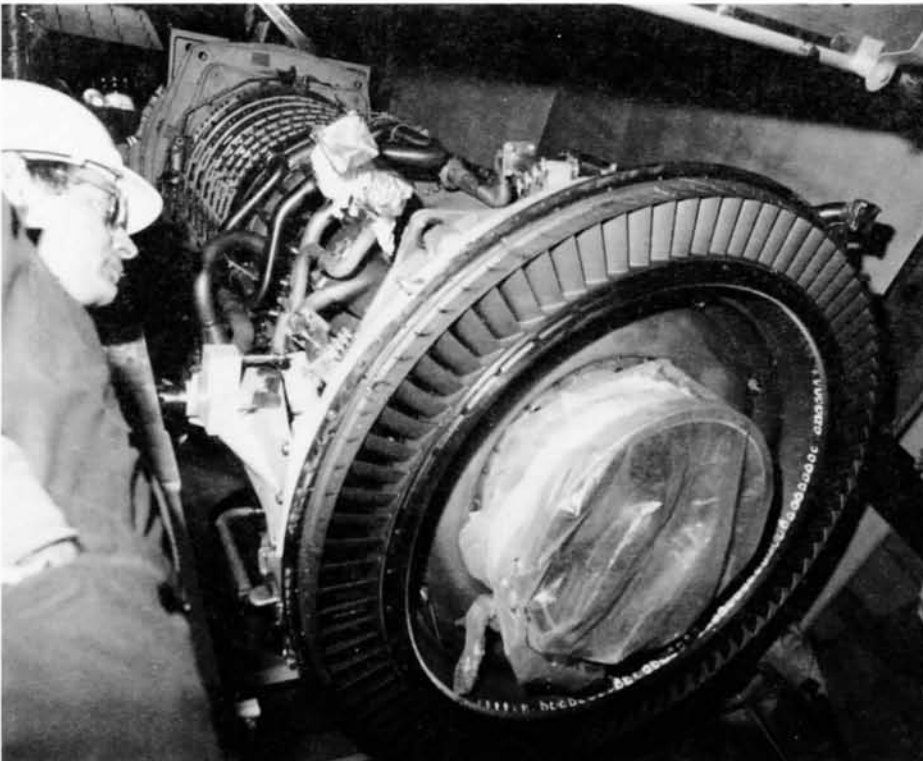
Fig. 2 A good view of the turbine end of the gas generator, now clear of the enclosure plenum. The #6 bearing has been protected by a sheet of plastic as it is the most vulnerable part of the gas generator when it is exposed like this.

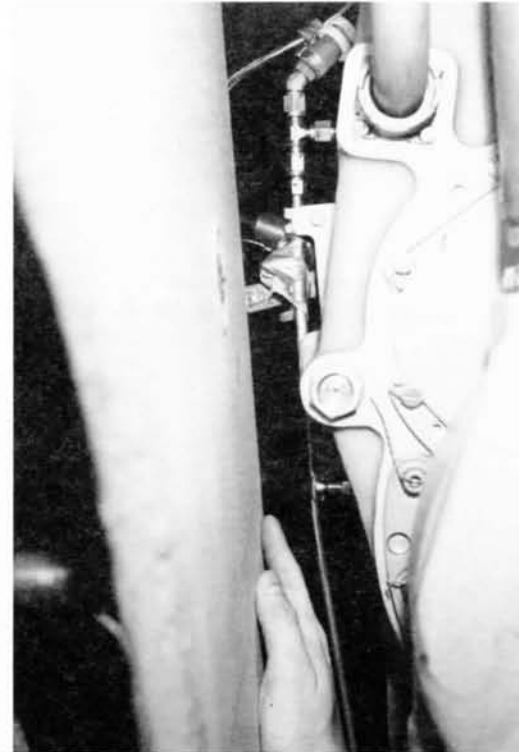
Fig. 3 Minimal clearances like this can be easily checked prior to removal with a representative-sized jig.

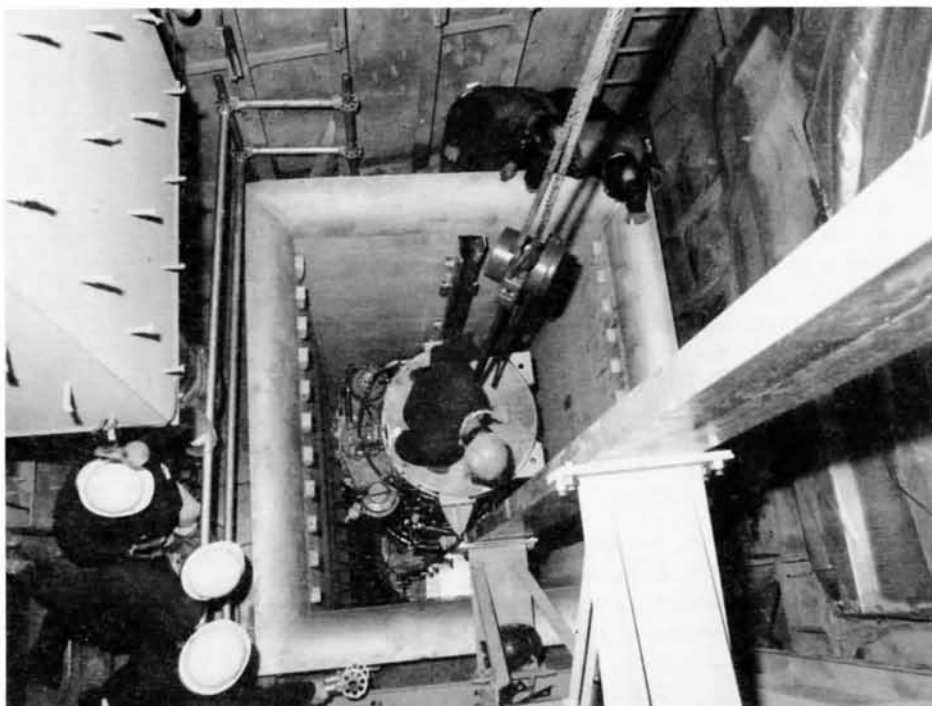
Fig. 5 An overhead view of the gas generator on the chain hoist as it clears the critical region.
