Maritime Engineering Journal

**HMCS *Kootenay*
Repairing the Damage**

HMCS *Kootenay* Collision Repair

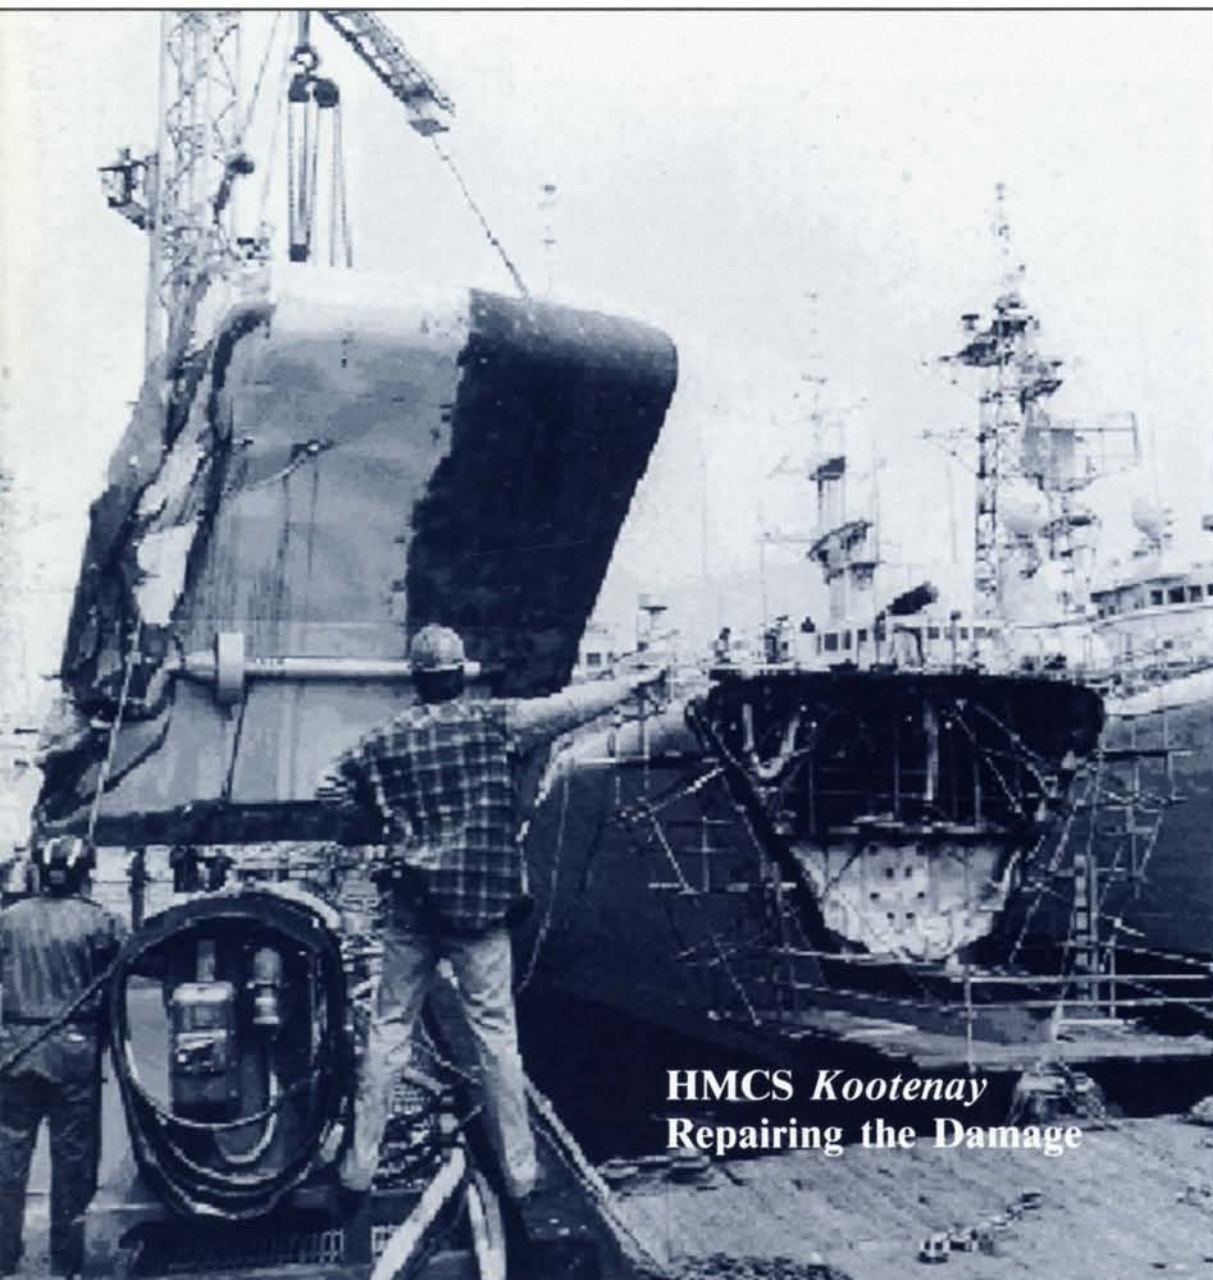
HMCS *Kootenay's* crushed bow unit is landed for replacement two weeks after the destroyer collided with a 60,000-ton freighter off Cape Flattery last June.
(Canadian Forces photo)

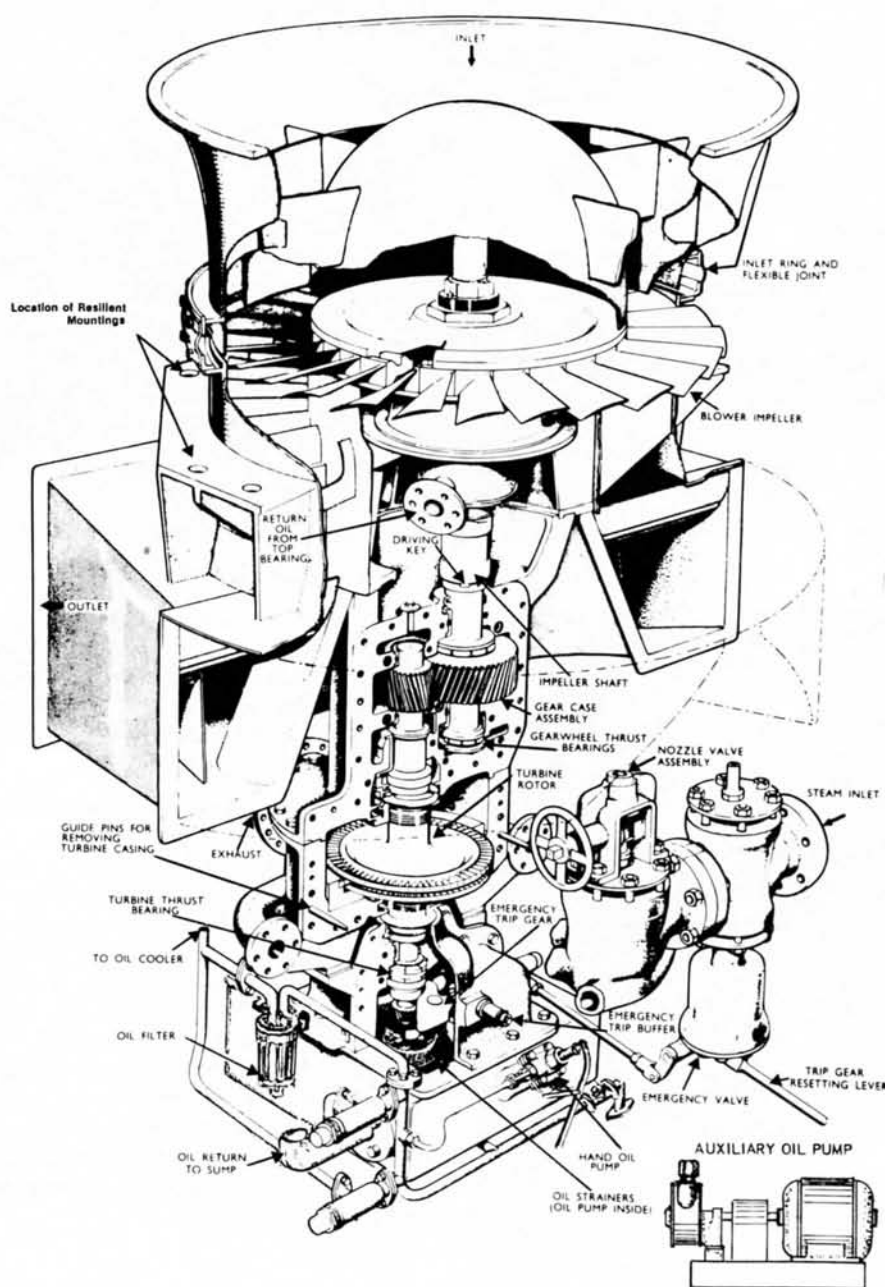
Fig. 1 Y-100 Turboblender General Arrangement

The failures were irritatingly unaccountable, occurring as they did at random under a wide variety of conditions, with little regard for occasion. Turboblenders failed while in the steady state at sea; during ship manoeuvring at low, intermediate and high speeds; entering and leaving harbour; and once during a full-power trial. One even failed in the early stages of a basin trial. The only thing that connected the failures was, in each case, a bent turbine rotor.

The severity of the rotor bends and the speed at which the failures commenced determined the extent of physical damage sustained by the rest of the machine. Some rotors had bent in one direction only. Others, in a most bizarre fashion, had bent in two diametrically opposite directions, as if they had been fixed at either end and flexed from side to side at the centre. Even stranger, some rotors had bent, damaged the stator, and gone straight again.

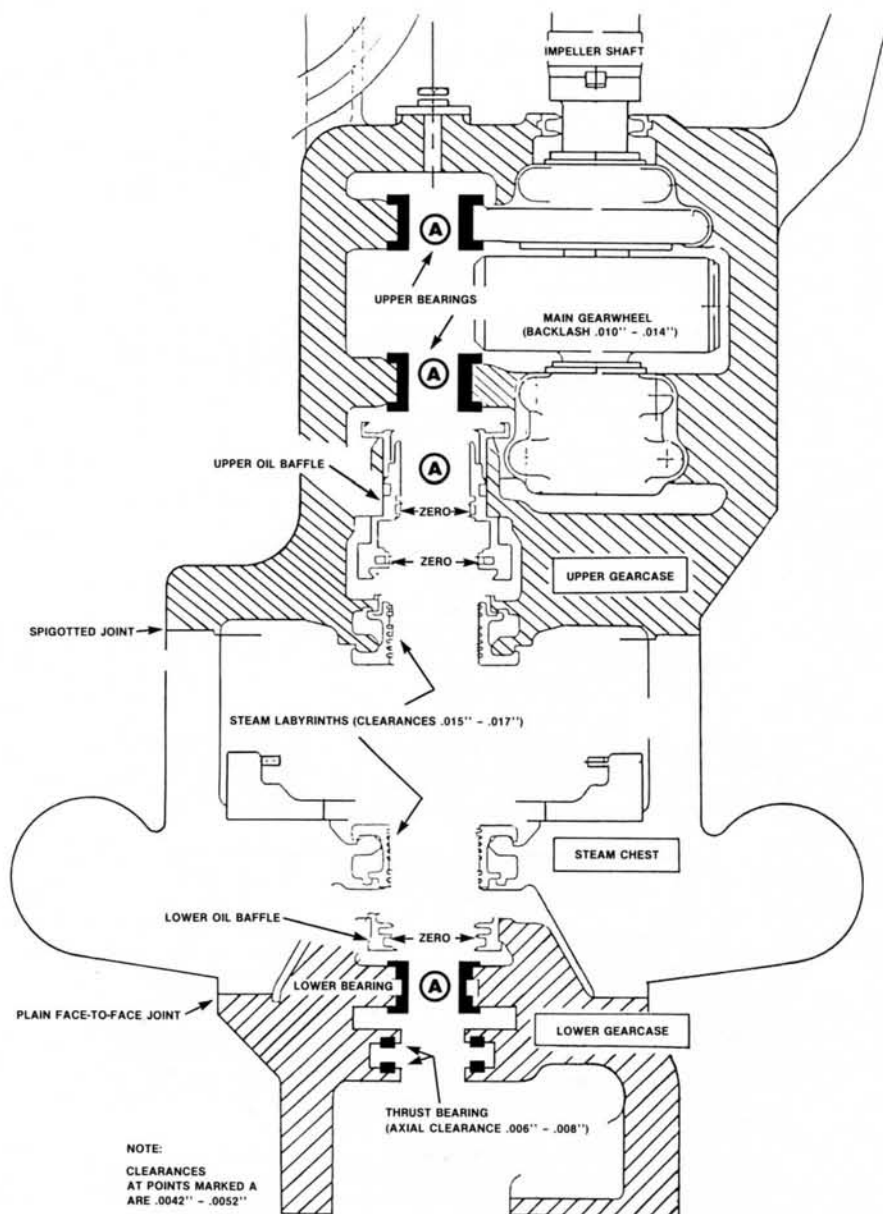
**Fig. 2 Y-100 Turboblower Casings with Rotor Removed
— 3 Casings and 2 Joints**

A more detailed examination of the turbine casing exposes a complex assemblage (see Fig. 2). The stator casing is comprised of three separate sections bolted together at two horizontal flanges. The upper section houses the gearing, the lower section the auxiliary drives and overspeed mechanism. The central section comprises a steam chest, housing the turbine stator nozzles and lower steam labyrinth.

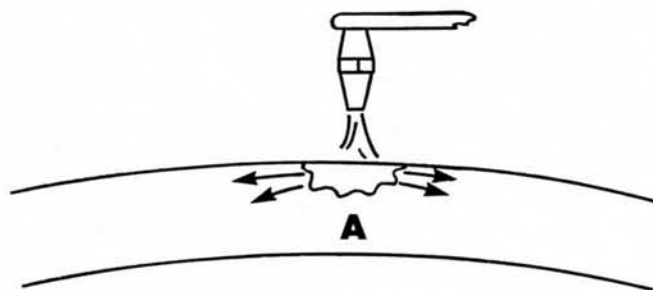
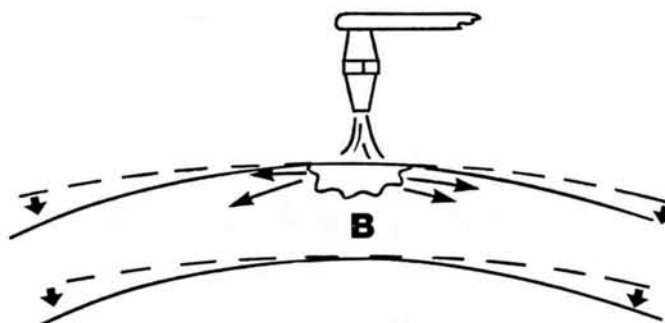
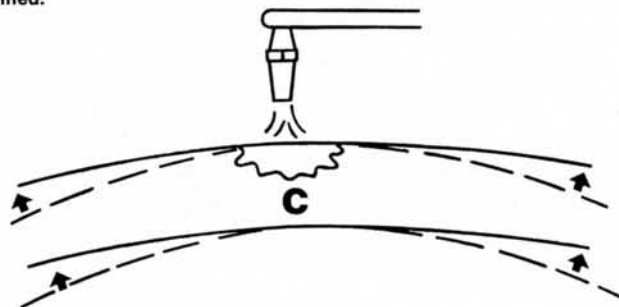
Fig. 3. Hot Spot Thermal Straightening Technique

Consider the bent rotor shaft (A):

A small area on the convex side of the bend is heated by a torch. The area under the torch warms and expands elastically. (In other words, if the heat were taken away at this stage the heated area would return to its original size.)

As it expands (B) it exerts forces against the untreated mass and causes the rotor to bend even further. This causes stresses to be set up in the unheated material in the opposite direction; i.e. the unheated material is being strained.

As heat continues to be applied (C) the hot spot area begins to approach plastic flow and in doing so loses its tensile strength. The forces created by the hot spot disappear. The residual stresses in the rotor's unheated material force the shaft into its original bent condition.

The damaged rotors were machined back to parent metal in the areas subjected to circumferential grooving or scoring and replated by a nickel electroplating technique. This reclamation method is straightforward and acceptable. Remachining follows, bringing the rotor back to original design; the areas affected by damage usually being around the steam labyrinths, oil baffles and bearings. Occasionally a pinion would have to be replaced. (These are a shrink fit on the turbine rotor.) Very rarely would repairs to blading take place. If a rotor had bent out of tolerance (as a majority of them had done), they were straightened by a "hot-spot" thermal straightening technique (*Fig. 3*).
